# BIANCONI CHAPEL BOHERLAHAN TIPPERARY CONDITION ASSESSMENT & CONSERVATION REPORT

# **CONSERVATION PLAN SUMMARY**

for proposed works to Bianconi Chapel, Boherlahan, Co. Tipperary

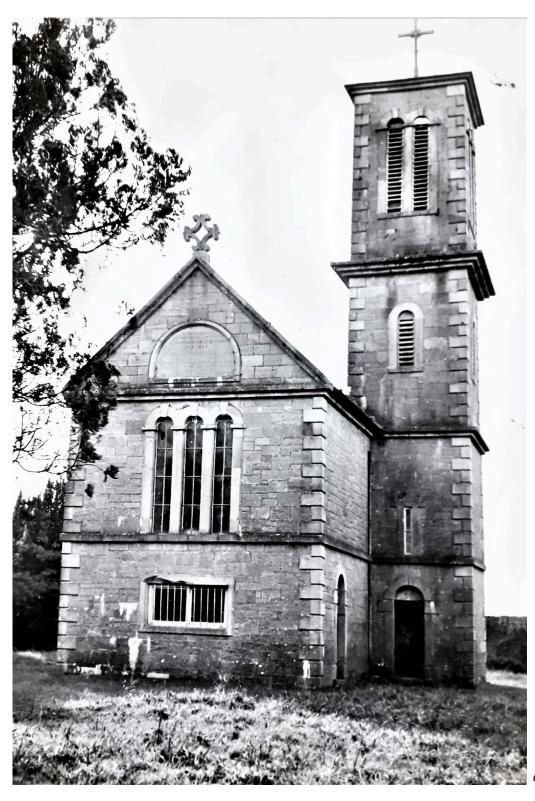
Fig. 6 - Bianconi Chapel, c.1930s. Capuchin Archives

It appears from the descriptions noted above and from its design, that the timber casement window is a later addition in order to provide enclosure. Its design and frame type are not as fine in quality and execution as the original fenestration. The timber window is also in situ in the historic photo.

This window should be investigated in closer detail to ascertain its materials, the extent and quality of more recent repairs and it's overall contribution to the reading of history. It is a later and heavier insertion, its existence as part of the chronology needs to be considered alongside the value of presenting Bianconi's original design. That said, it is unlikely that returning this to be a permanent unglazed frill scenario would be desirable. The possibility of inerting a modern minimalist steel frame which would appear closer to the original arrangement should also be considered.
